Volume II

Appendix D.7

Working Scenario

The Working Scenario was the result of a joint effort between the Columbia Accident Investigation Board (CAIB) and the NASA Accident Investigation Team (NAIT). The report was written beginning early in the investigation to track the current understanding of the events that led to the loss of *Columbia*. As such, the report evolved over time as facts became known, theories were developed or disproved, and NASA and the Board gained knowledge of the accident sequence.

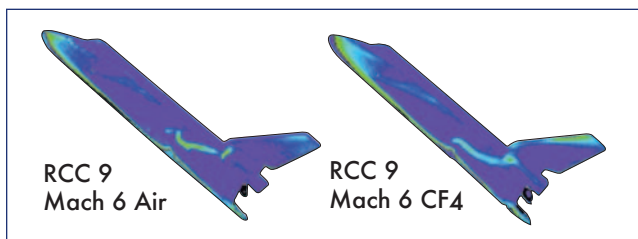
Figure 5-26. Wind tunnel test results for RCC panel 9 missing and resulting in increased heating to OMS pod.

The increased heating implies that damage/erosion to the RCC panel 8 area had increased or that at least one carrier panel had been lost. The increased heating is also consistent with an increased mass flow rate due to the nature of the entry environment. The dynamic pressure and stagnation heat flux had more than doubled by this timeframe when compared to a few minutes after EI. There are three additional communication dropouts that follow at approximately 8:52:09 EST to 8:52:31 EST (EI + 480 to 502 sec.). Again, these dropouts are consistent with molten aluminum and other metals being released into the environment surrounding *Columbia*.

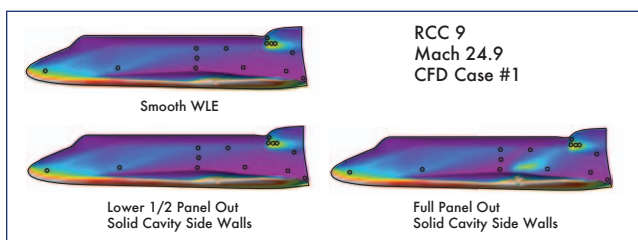
Figure 5-27. CFD results for no damage, partial damage, and full damage to RCC panel 9 show increased heating on side fuselage and OMS pod.

These off-nominal temperature rises were caused by a change in the flow field along the upper portion of the left wing as the wing leading edge (WLE) and wing spar damage progressed. The mechanism was a shift in the vortices due to venting on the upper portion of the wing and is similar to the previous discussions on lower than expected OMS pod temperatures. Wind tunnel testing and CFD analysis confirmed that WLE damage on RCC panels 8 and 9 could cause increased heating to the OMS pod due to disturbed upper surface flow or flow impingement caused by re-directed flow from the lower surface. Additionally, the molten Inconel 718 and A-286 spray onto this area are indications that this flow is the cause of these temperature rises. Figure 5-26 (from wind tunnel test results) is a representative example of increased heating on the left fuselage and OMS pod due to RCC panel 9 damage from wind tunnel test results. Figure 5-27 shows a similar picture of the left side as determined by CFD analysis. Note that neither the wind tunnel testing nor the CFD analysis accounts for increased heating that is likely due to molten metal contacting the OMS pod.

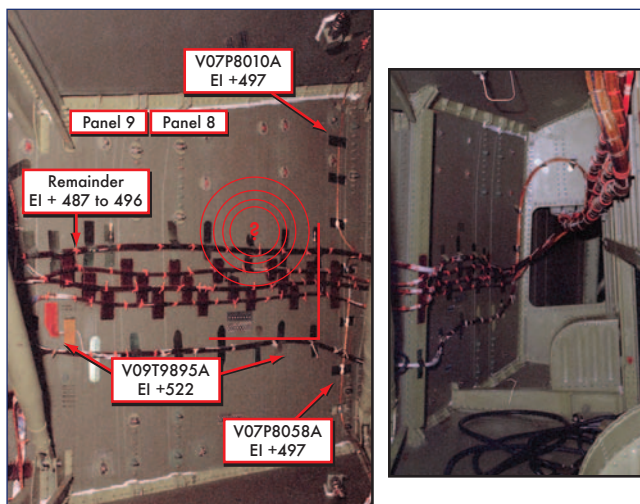
Figure 5-29. Cable routing on wing leading edge and wheel well wall.

The final technique used was an examination of the wire failures on the wing leading edge spar. These wire runs are shown in Figure 5-29. The first measurement loss was a MADS upper left wing pressure measurement, which failed at approximately 8:52:16 EST (EI + 487 sec.). This measurement is contained in the upper wire bundle in the left photo in Figure 5-29. The combination of these three separate and distinct analyses results in a range of wing spar breach times as early as 8:51:14 EST and as late at 8:52:16 EST (EI + 425 to 487 sec.).

Immediately after the breach, hot gas inside the wing began to heat the remaining wire bundles that contained real-time telemetry and the recorded MADS measurements. Figure 5-29 shows an inside-the-wing view of the approximate breach location based on this wire failure analysis. The view on the left is of the panel 8/9 spar location. This area is not visible in the right photo, which contains the transition spar and a view of the three wire bundles along the outside of the wheel well wall. Figure 5-31 shows the overall spar breach location with respect to the rest of the wheel well. The distance from the spar to the wheel well wall in this area is approximately 56 inches, as shown in Figure 5-32. Figure

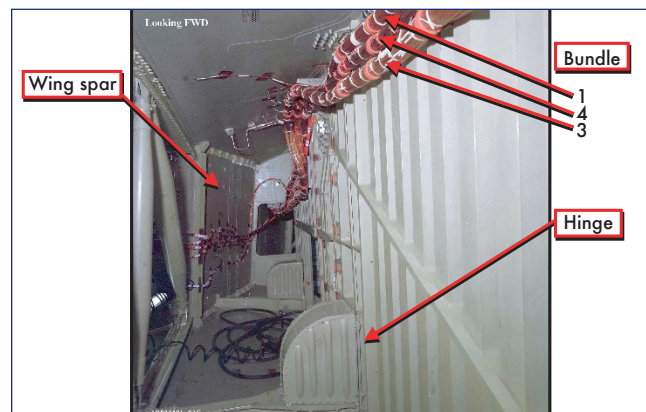
One hundred sixty-three other measurements failed very quickly over the next two minutes. Figure 5-34 is a plot of the percentage of measurements lost as a function of time from EI. The first measurements to fail are all located on the wing leading edge spar as shown by the purple line on the plot. Bundles 1, 3, and 4 along the wheel well (shown in Figure 5-35) began to fail about 14 seconds after the first spar measurements.

Figure 5-35. View of cables running along outside of wheel wall cavity bulkhead.

Four additional measurements failed after 8:54:16 EST (EI + 605 sec.) with the last starting to fail at 8:56:24 EST (EI + 735 sec.). This last measurement failure took over a minute to fail completely. Figure 5-34 and Figure 5-35 show the measurement loss timing and the wire bundle runs along the wheel well. Although almost all measurements internal to the wing failed, two strain measurements on the 1040 spar (forward of the wheel well) were unaffected and produced data until loss of all MADS data at 9:00:13 EST (EI + 964 sec.). Figure 5-36 shows the location of the sensors on the forward

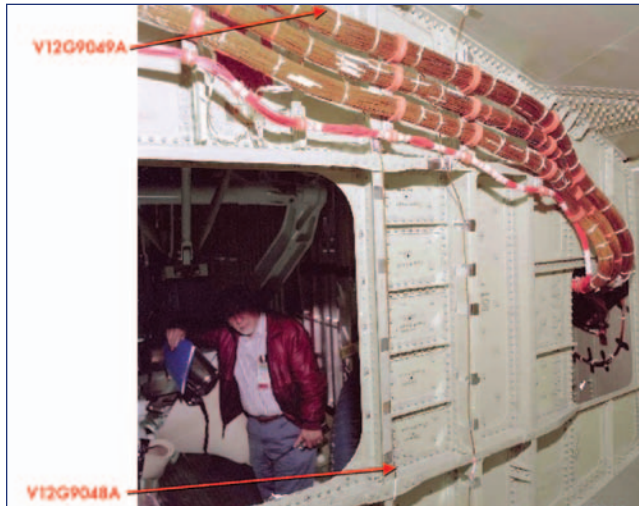
wheel well spar. The fact that these measurements are available until loss of data are important indicators that the RCC breach could not be forward on the panel 6 area since these measurements would have been lost as well (see Figure 5-32). These measurements also record key changes in strain that help indicate some of the changes that the left wing underwent as the remainder of the entry events unfolded.

Figure 5-36. Strain measurements on 1040 spar.

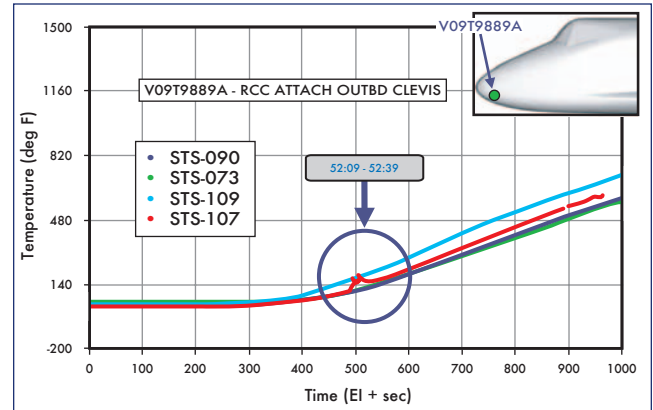
Coincident with the spar breach at approximately 8:52:09 EST (EI + 480 sec.), the nose cap RCC attach clevis temperature had an off-nominal change in rise rate when compared to previous missions. This rise rate was abnormal for approximately 30 seconds and ended at 8:52:39 EST (EI + 510 sec.). The exact cause of this abnormal temperature rise is not known, but the timing is coincident with the breach of the wing leading edge spar. An explanation is that the abnor-

mal rise is an instrumentation anomaly caused by multiple wire failures in this timeframe. This measurement response is shown in Figure 5-37 along with the same measurement for several other *Columbia* missions. This figure also shows the location of this internal nose cap measurement on the very forward portion of the left fuselage.

Figure 5-37. Off-nominal temperature rise rate in nose cap RCC attach clevis.

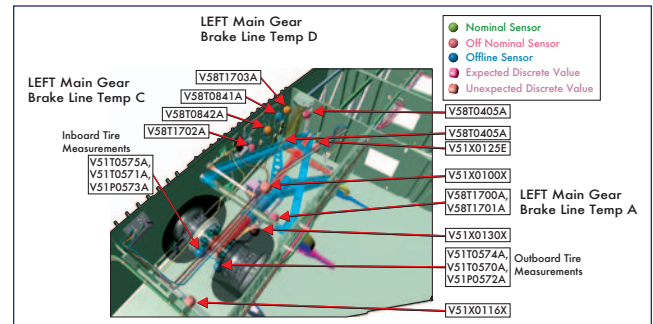
Figure 5-38. Location of sensors in the LH wing wheel well.

nominal. The first indication of any anomalous Operational Instrumentation (OI) was a small increase in the left main gear brake line temperature D measurement at this time (see Figure 5-38). Within one second of this time, there is a lower 1040 spar (forward wall of the wheel well) strain measurement that shows an off-nominal increase in strain (see Figure 5-39). These are both indications that the breach in the wing leading edge spar had allowed hot gas to reach the wheel well area, most likely through vent paths around the hinge covers, which allowed hot gas into the wheel well cavity.

At the same time as the stress was relieved on the lower 1040 spar, two left main gear outboard tire pressures began trending toward an off-scale low reading. This was preceded by a slight upward trend at 8:57:19 EST (EI + 790 sec.) for both pressure measurements. This is an indication of extreme heating of both the left outboard tire and the surrounding instrumentation. The tire has significant thermal mass and substantial heating would be required to produce the slight temperature rise. By 8:58:56 EST (EI + 887 sec.), all left main gear inboard and outboard tire pressure and wheel temperature measurements were lost indicating a rapid progression of damage or wire burning inside of the wheel well. Figure 5-38 shows the location of these pressure sensors.

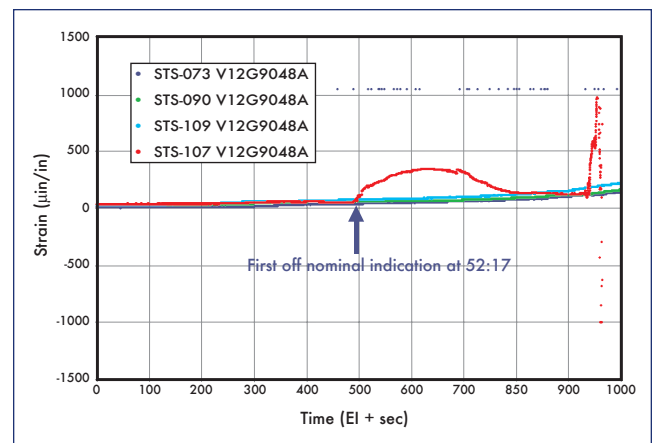
Figure 5-39. Strain rise in lower 1040 spar cap.

ous Figure 5-39). The upper strain measurement continued to increase during this timeframe indicating that the heating was different on the upper and lower portions of the wheel well and 1040 spar. Although the response of the 1040 spar strain is not completely understood, structural analysis indicates that the strain response can be completely explained by thermal stresses caused by severe heating of the wheel well wall and internal wing components.

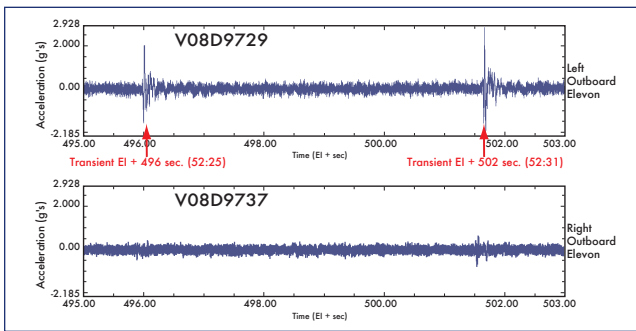
At approximately 8:52:25 EST (EI + 496 sec.), the left outboard elevon wideband accelerometer showed an unusual 2 g peak-to-peak acceleration (see Figure 5-40). This is consistent with the timing of the many wire failures within the left wing and the timeframe when the spar breach occurs. Additionally, there are two unexplained communication dropouts in this same timeframe. Another 3 g peak-to-peak acceleration anomaly was observed at 8:52:31 EST (EI + 502 sec.). Additional temperature measurements (left main gear brake line temp A and C) in the wheel well area (see Figure 5-38) began an off-nominal rise at 8:52:41 EST (EI + 512 sec.).

Figure 5-40. Outboard elevon accelerometer responses at 8:52:25 and 8:52:31 EST (EI + 496 and 502 sec.).

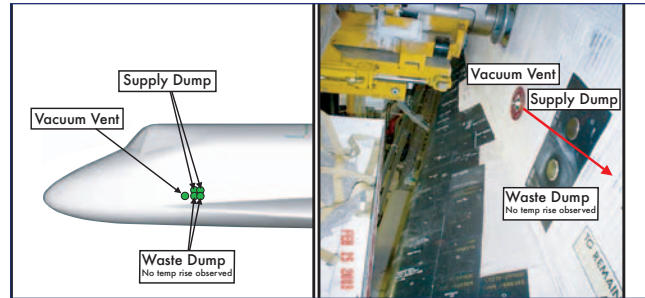
The elevon response event was followed by a change in the rise rate for two supply nozzle temperatures and the vacuum vent nozzle temperatures at 8:52:32 EST (EI + 503 sec.). The off-nominal rise rate occurred for approximately 15 seconds for the supply nozzle temperatures and 23 seconds for the vacuum vent temperatures. The location of these nozzles on the left side of the fuselage is shown in Figure 5-41, and the arrow indicates that they could have been located along a line of disturbed flow. The short, abnormal rise rate is unexplained, has not been observed on any previous Shuttle missions, and may not be associated with the upper wing disturbed flow caused by the leading edge damage. Unlike the RCC nose cap clevis temperature, the instrumentation appears to have been valid for both nozzles. Plots of this off-nominal temperature rise for one of the supply nozzle temperatures and the vacuum vent nozzle are shown in Figure 5-42.

Figure 5-41. Location of supply dump and vacuum vent nozzles.

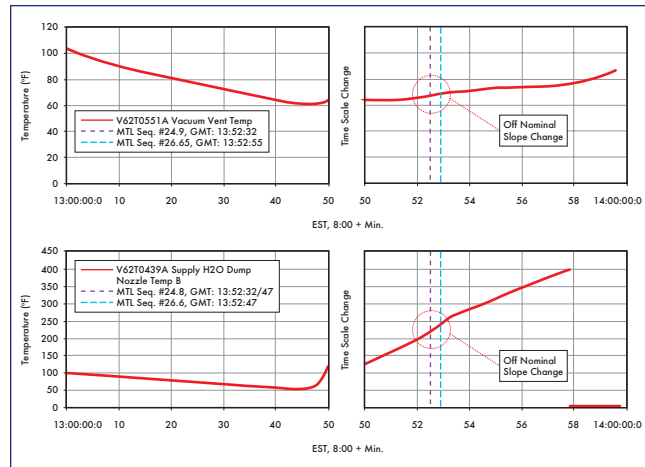
Figure 5-42. Off-nominal temperature for supply nozzle and vacuum vent nozzle.

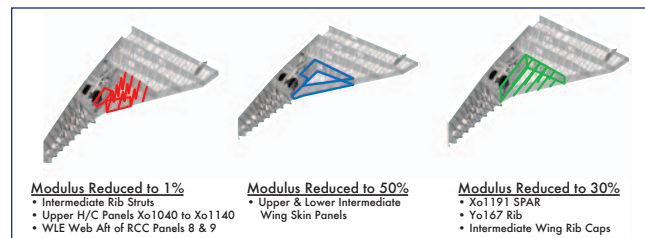
Structural and aerodynamic analysis of wing deformation was performed without any type of recession in the wing lower surface. An assumption of 70 pounds per square foot was used for wing loading. Heat transfer coefficients were updated from previous coupled venting and thermal models for the left wing. A structural model was used along with the heating equivalent of a 10 inch diameter breach in the wing spar beginning at 8:52:16 EST (EI + 487 sec.) assuming 100 percent of the energy from this hole was transferred to the wing interior. Two different cases were analyzed: one with no breach in the upper wing skin and another with a 5 inch diameter breach in the upper skin at 8:54:37 EST (EI + 628 sec.) when a significant visual flash event was observed. Both cases showed that the temperatures of the wing skins, wing spars, and the wheel well wall were high enough by 8:58:19 (EI + 850 sec) that significant damage to the wing structure would occur. Figure 5-45 shows the potential area of damage and that significant deformation of the intermediate wing area and/or a recession in the lower surface is possible.

It is difficult to postulate the exact wing deformation that occurred. One case is localized leading edge damage, resulting in global wing deformation. Local deformation was relatively small, less than 1.0 inch in the damage area with a 0.25-inch global increase in wing tip deflection. Delta rolling and yawing moments were calculated for this case, and they were very small, approximately +0.0001 for roll and -0.0001 for yaw. Another case looked at deformation resulting from the loss of three internal ribs. Again, the local deformation

Figure 5-45. Modeling results show potential area of damage and that significant deformation of the intermediate wing area and/or a recession in the lower surface are possible.

was small (approximately 5 inches) and the resulting aerodynamic moments were small. These delta moments are in the correct direction for change in the aerodynamic moments, but are not nearly large enough in magnitude when compared to the flight derived moments for the time after the roll moment trend reversal. To achieve the aerodynamic response observed in the flight data, more significant damage to the wing would have been required.

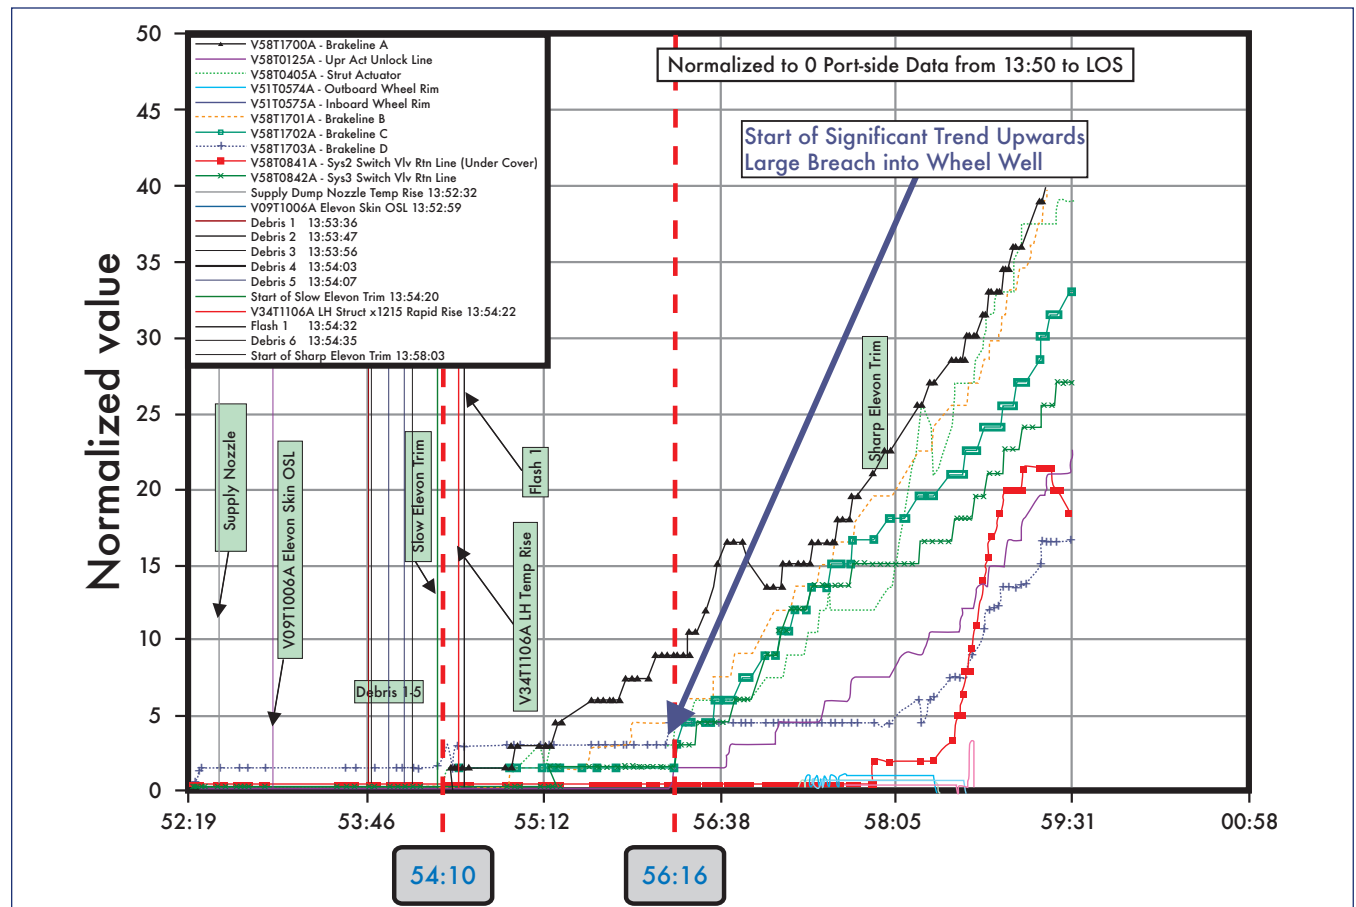
By 8:56:16 EST (EI + 727 sec.), hot gas had penetrated the wheel well wall as indicated by off-nominal rise rates in several hydraulic line temperatures (see Figure 5-46). Preliminary analysis indicates that it is feasible to have had some gas intrusion into the wheel well area as early as 8:52:39 EST (EI + 510 sec.) since a honeycomb access panel

Figure 5-46. Temperature data in left wheel well trends up.

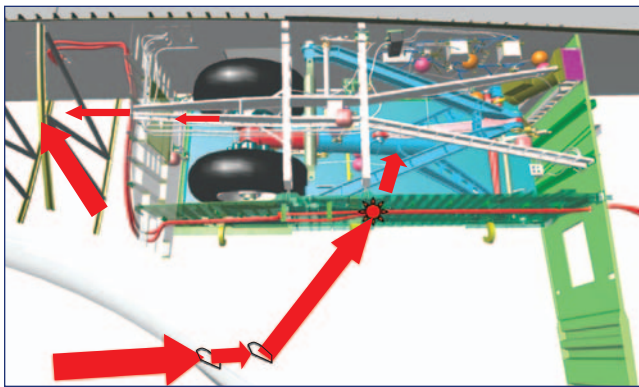
Immediately after the wheel well wall was breached, a hot gas plume began to flow on to the left main gear strut (depicted in Figure 5-47), leading to excessive strut erosion. A wheel well wall breach in this area is consistent with the erosion pattern observed on the recovered left main gear strut. Even after damage had significantly progressed into the wheel well, the orbiter initiated the first roll reversal at 8:56:30 EST (EI+741 sec.). The maneuver was completed by 8:56:55 EST (EI+766 sec.), and the vehicle was in a normal left bank. The guid-

Figure 5-47. Hot gas breaches the wheel well.

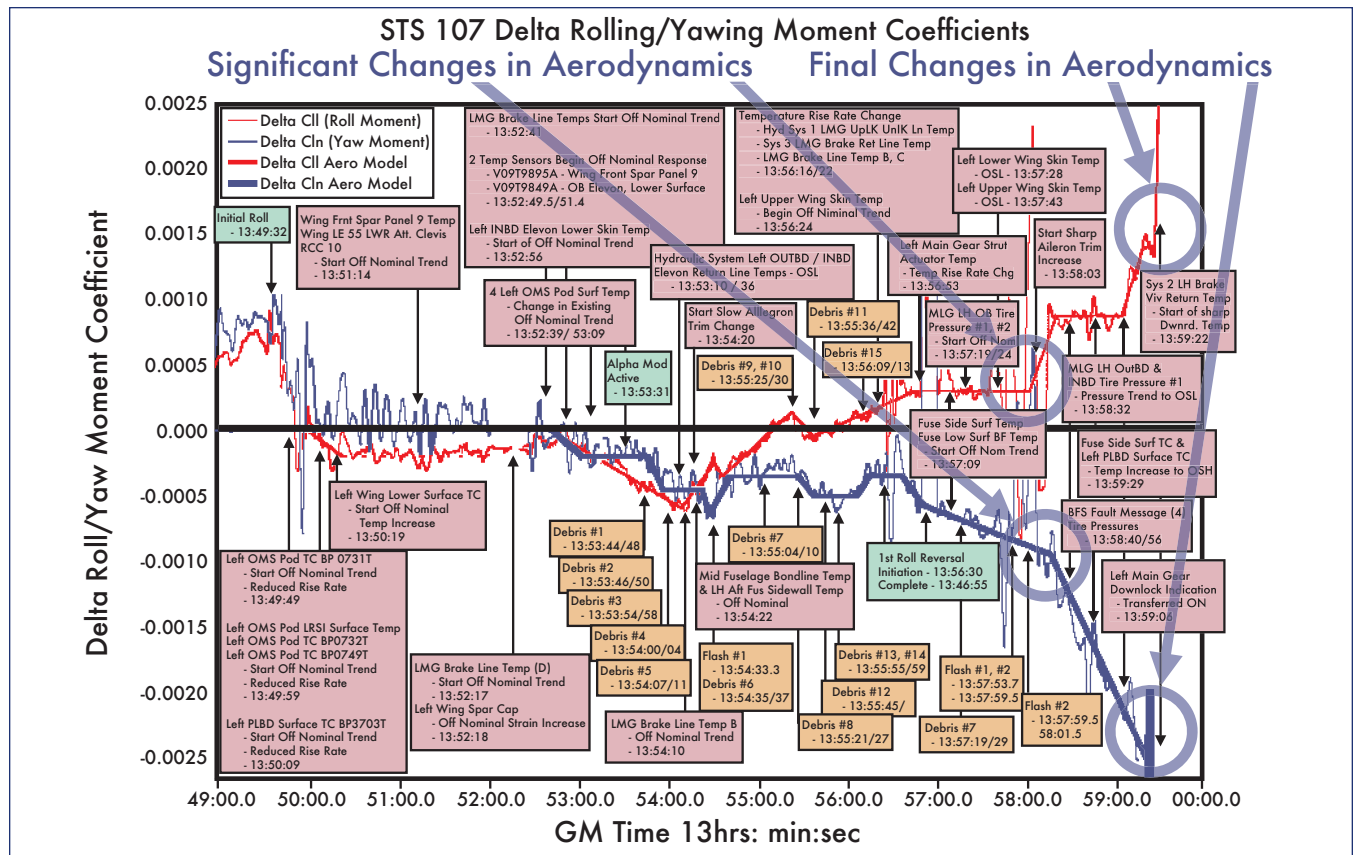
As shown in Figure 5-49, this strain response appears to be consistent with another sharp change in the slope of the derived delta rolling moment coefficient that occurred slightly earlier at 8:58:03 EST (EI + 834 sec.), along with several additional debris events. The vehicle responded to this event with a sharp change in the aileron trim. These events indicate that there was another significant change to the left wing configuration at this time. Wing deformation and an increase in the lower surface recession along with a loss of additional bottom tiles are possible explanations for this behavior.

As shown in Figure 5-49, there was another abrupt change in the vehicle aerodynamics caused by the continued progression of left wing damage at 8:59:26 EST (EI + 917 sec.). This change was a significant increase in the positive delta roll moment and negative delta yawing moment, indicating increased drag and lift from the left wing. *Columbia* attempted to compensate for this by firing all four right yaw jets. By this point the MCC had lost all telemetry data at 8:59:23 EST (EI + 914 sec.). Even with all four right yaw jets and a maximum rate of change of the aileron trim, *Columbia* was unable to control the side-slip angle that was slightly negative (wind on the left side of the fuselage) during much of the entry. The side-slip angle changed sign at 8:59:36 EST (EI + 927 sec.) indicating that vehicle loss of control was imminent (side-slip angle is an aerodynamics term for the angle between the relative wind velocity and the vehicle direction of motion, or velocity vector).

Figure 5-49. Increased wing deformation and wing recession leads to significant vehicle aerodynamic changes.

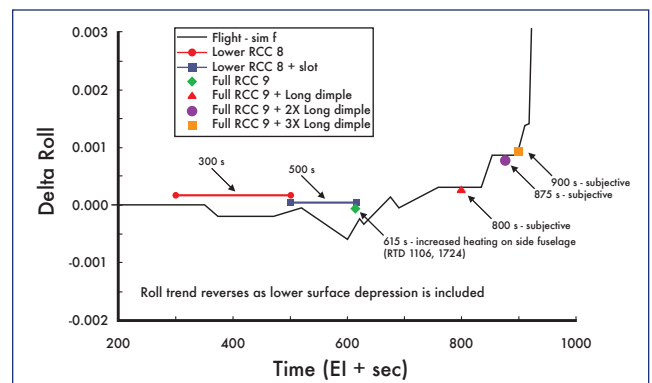
Figures 5-50 through 5-52 show the flight derived delta roll, yaw, and pitch aerodynamic moments, respectively, along with the tested damaged configuration results that are consistent with the flight data. The intent of the remainder of this

Figure 5-50. Wind tunnel testing configurations that match delta roll moment data.

the wing leading edge and flow through a slot onto the upper carrier panel is consistent with the first observed aerodynamic response, which occurs at 8:52:29 EST (EI + 500 sec.). This can be observed in Figure 5-50 and Figure 5-51 as a slow negative trend in delta roll and yaw. Figure 5-55 shows the wind tunnel test results for three different cases: missing lower RCC panel 8, missing panel 8 combined with a 4 inch diameter hole in the upper carrier panel 8, and missing RCC panel 8 with a slot through the upper carrier panel. The slot was shown to produce the increased delta yaw observed during flight as well as the upper surface flow disturbances on the OMS pod and left side fuselage, which were also observed during flight by abnormal temperature rise rates.

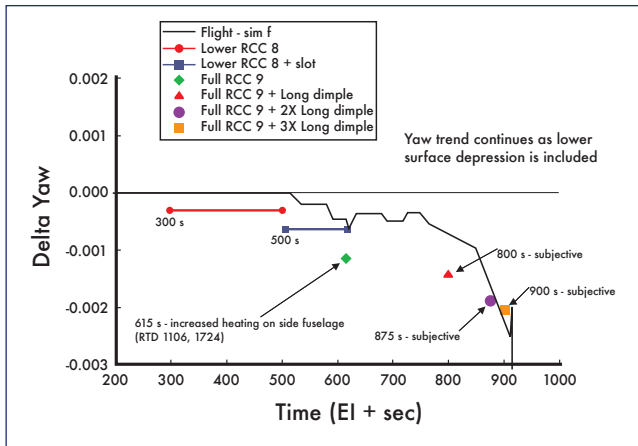
Figure 5-51. Wind tunnel configurations that match delta yaw moment data.

Initially, the recessed area would have been relatively small; however, it would gradually grow over time to cause the delta roll moment to increase. By 8:57:29 EST (EI + 800 sec.) wind tunnel testing showed that the depression has to be on the order of 20 feet long, two feet wide, and 5.3 inches deep along with panel 9 missing in order to duplicate the delta roll coefficient shown in Figure 5-50. This configuration provides a delta yaw moment that is slightly larger than was observed, but is consistent with a decreasing negative delta yaw moment observed in this timeframe (Figure 5-51).

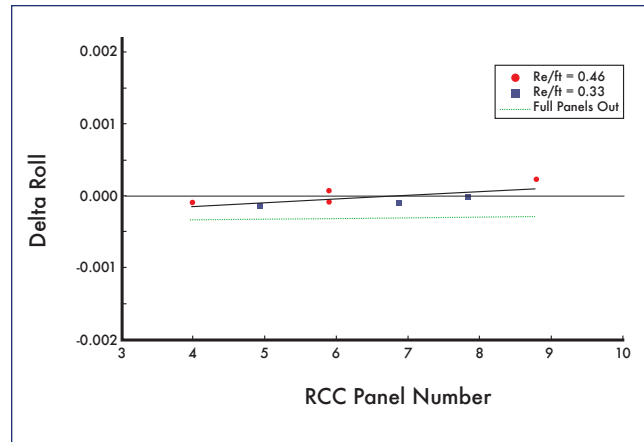
Figure 5-53. Delta roll for lower half and full panel RCC panel missing.

As discussed previously, the reconstructed aerodynamic moments showed little to no change due to damage through 8:52:29 EST (EI + 500 sec.). Based on the forensics data discussed in Section 5.3, the most likely region of initial damage was in the lower part of RCC panel 8. Wind tunnel testing in the Langley Research Center (LaRC) CF4 tunnel indicated that a missing bottom part of RCC panel 8 (from the apex to the lower carrier panel) matches the initial aerodynamic increments, which show a minimal effect on the overall vehicle aerodynamics. In fact, even a full missing panel 8 produces only a small change to the roll and yaw aero moments. Figure 5-53 and Figure 5-54 show the results of this LaRC evaluation.

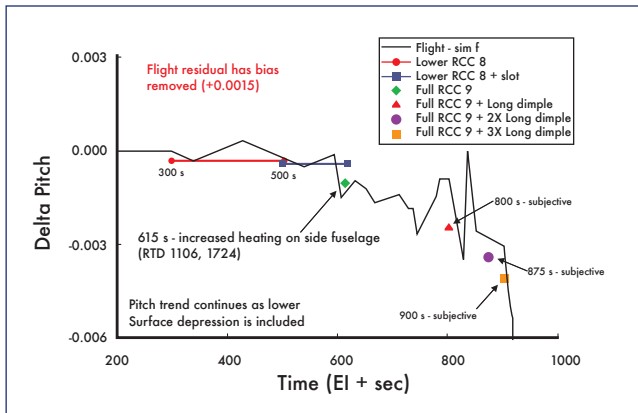
Figure 5-52. Wind tunnel configurations that match delta pitch moment data.

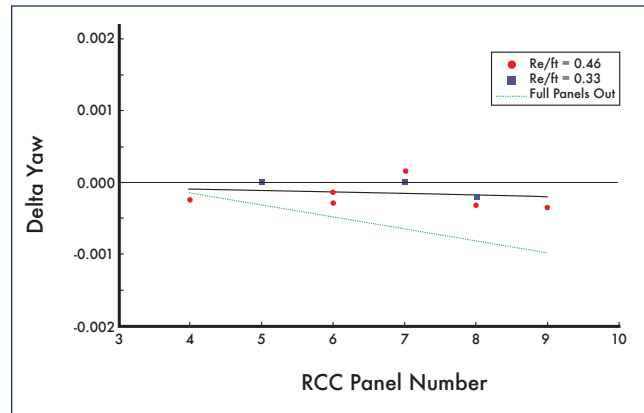
Figure 5-54. Delta yaw for lower half and full panel RCC panel missing.

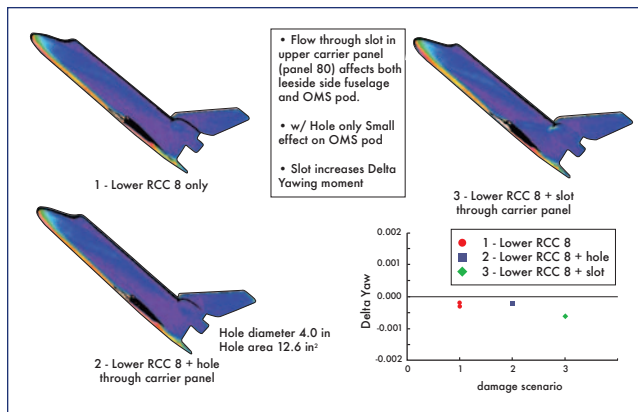
It is possible that a hole through the upper wing developed in the 8:54:11 EST (EI + 600 sec.) to 8:54:31 EST (EI + 630 sec.) timeframe. This is consistent with a lull in the measurement failure rate in the wire bundle along the wheel well that was discussed earlier in Section 5.4.3. Wind tunnel testing and CFD analysis have shown that sizable holes through the wing have little to no effect on the aerodynamics and heating on the left side of the fuselage and OMS pod. A representative sample of this work is shown in Figure 5-55 as damage scenario number 2.

Figure 5-55. Wind tunnel testing results for missing lower carrier panel 8 and a slot and hole through wing.

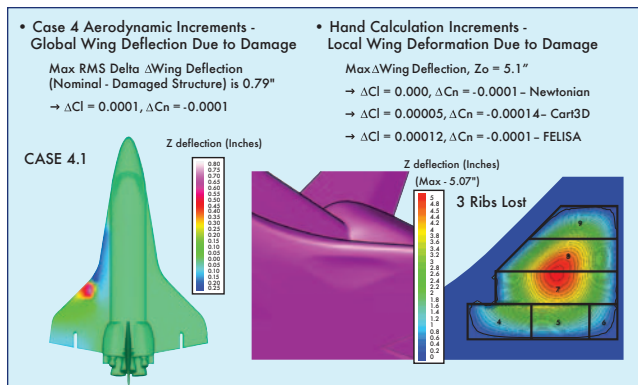
The next significant aerodynamic event occurred at 8:54:11 EST (EI + 602 sec.) when a dramatic reversal of the aero rolling moment trend occurs. By this time hot gas and an internal plume environment had severely degraded the structural integrity of some of the intermediate wing support structure leading to wing deformation. Three different configurations were tested to validate the theory of wing deformation. The first involved global wing deflection of up to 0.79 inches due to damage and is depicted in Figure 5-56. CFD analysis of this configuration showed extremely small aero moment response for yaw and roll that does not match the flight derived data. More substantial local wing skin deformation with a maximum deflection of 5.1 inches due to three ribs missing along with other internal wing damage was examined using CFD tools. Again, these results produced only small aerodynamic moment changes, which did not match the flight-derived data.

Figure 5-56. CFD analysis of wing deformation.

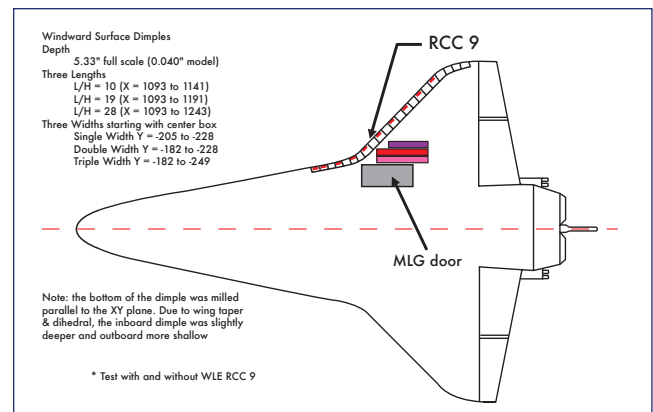
The third and final configuration that was tested was a depression in the lower surface of the wing caused by the significant structural damage caused by the hot gas plume environment internal to the wing. A previous section (5.4.5) discussed the internal structural damage that was most probable in this timeframe. LaRC wind tunnel testing and CFD analysis were performed for several different configurations of lower surface recessions shown in Figure 5-57. The data shows that it is feasible for a recession to cause

Figure 5-57. LaRC wind tunnel testing of lower surface depressions.

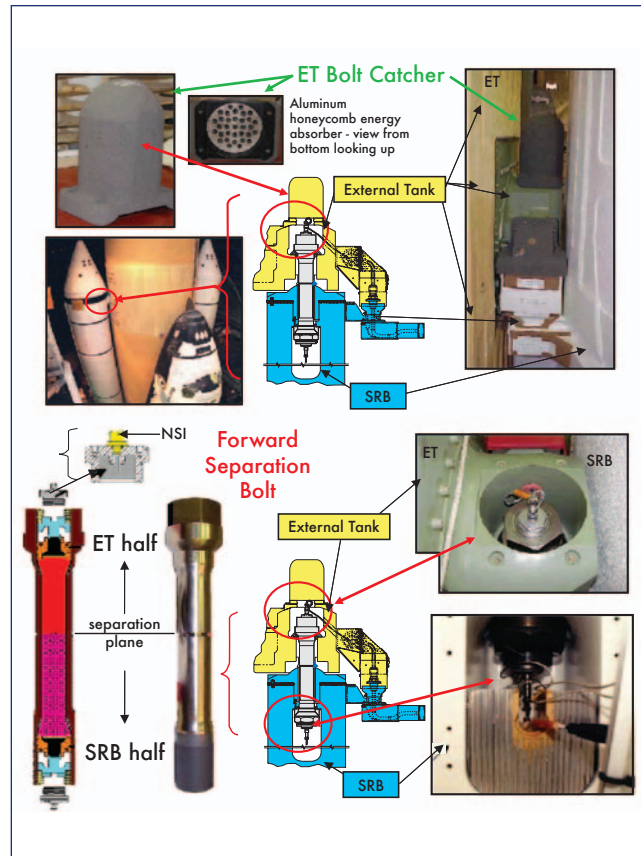
Four blocks on the STS-107 SRB fault tree remain open pending completion of forward bolt catcher testing. The bolt catcher, shown in Figure 7-1, was not qualified as an assembly, and structural qualification testing was not representative of the current flight configuration. The exact magnitude of loads transmitted to the bolt catcher housing cannot be determined based on available data. The SLA-561 thermal protection system (TPS) material on the bolt catcher was qualified by test and analysis for general ET application, but no pyrotechnic shock testing was performed. There is no test data available on the bolt catcher honeycomb dynamic crush strength versus separation bolt velocity, and random pressure loading from the NASA Standard Initiator (NSI) ejection was not included in the original qualification tests. Lastly, the running torque/break-away torque was not measured during STS-107 bolt catcher fastener and ET range safety system (RSS) fairing installation, which is used to verify the insert locking feature is in place. A review has determined that the bolt catchers and RSS fairings were installed and secured for flight with the correct bolts and final torque. Testing is in work to close the four remaining fault tree blocks, but initial static tests results show failure below the required safety factor of 1.4.

Figure 7-1. Details of SRB/ET forward separation bolt catcher assembly.

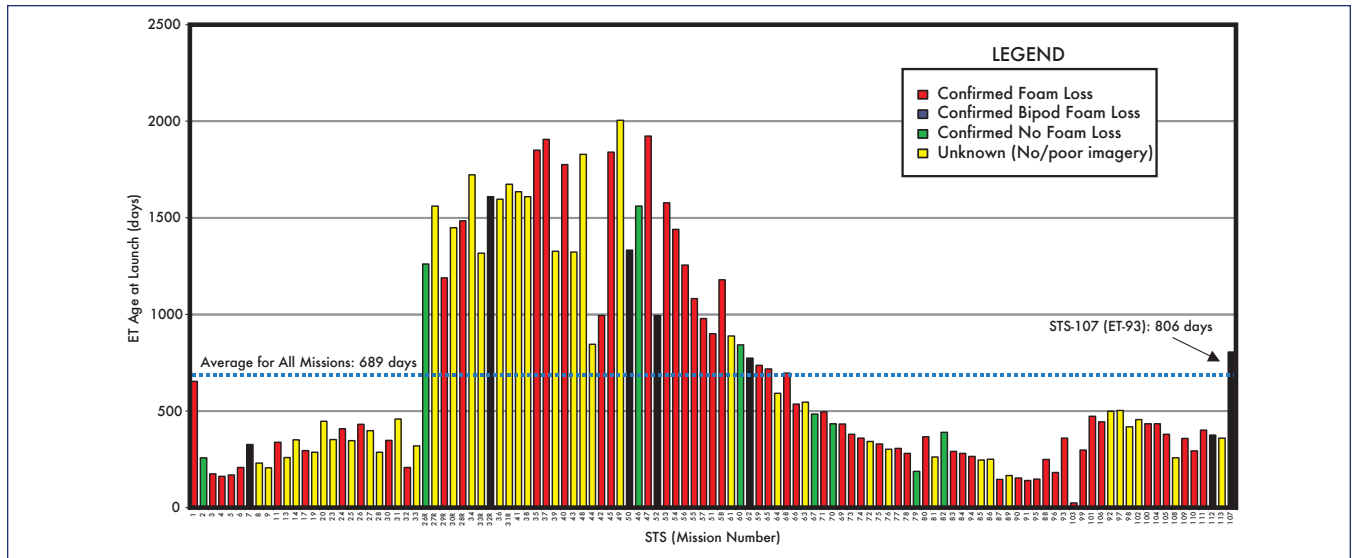
Figure 9-1. ET age for all STS missions.

The ET age was compared for various flights, presented in Figure 9-1. As shown in Figure 9-2, the ET age for STS-107/ET-93, 806 days, falls above the 95% confidence interval upper limit for the average age of all tanks, mean value 689 days, as well as the average age for all tanks with known bipod foam loss. STS-107/ET-93 also falls within the 95% confidence limit for missions with known bipod foam loss. Although the upper bound of the 95% confidence interval of the age of missions with bipod foam loss appears to be greater than the other groups in Figure 9-2, the 95% confidence interval limits of the different groups overlap each other. Therefore, data are inconclusive as to whether a correlation can be drawn about ET age and bipod foam loss.

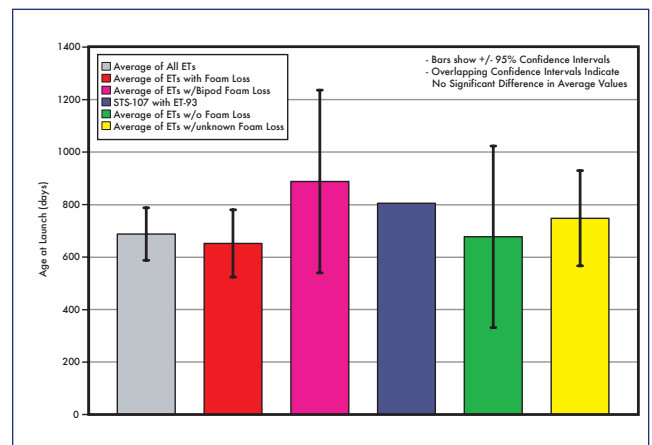
Figure 9-2. ET age for STS-107 compared to ET age for missions with and without bipod foam loss.

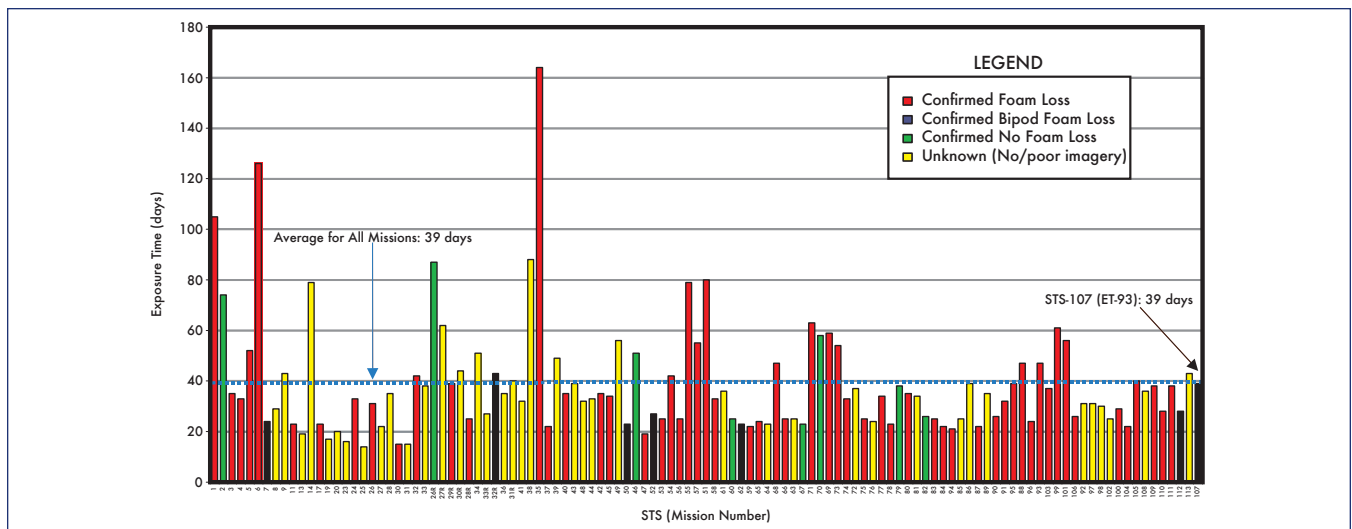
Figure 9-3. ET exposure time (to weather) prelaunch for all STS missions.

Note that the STS-107/ET-93 exposure time, 39 days, is the same as the mean value for all STS flights. As shown in Figure 9-4, the STS-107/ET-93 exposure time falls within the 95% confidence limit of all missions' ET exposure time, as well as the time confidence limits for flights with or without known bipod foam loss. The STS-107/ET-93 exposure time is larger than the 95% confidence upper bound for missions with known bipod foam loss. However, as stated above when discussing ET age, the 95% confidence limits of the different groups in Figure 9-4 overlap each other, and data are inconclusive as to whether ET exposure time and bipod foam loss can be correlated.

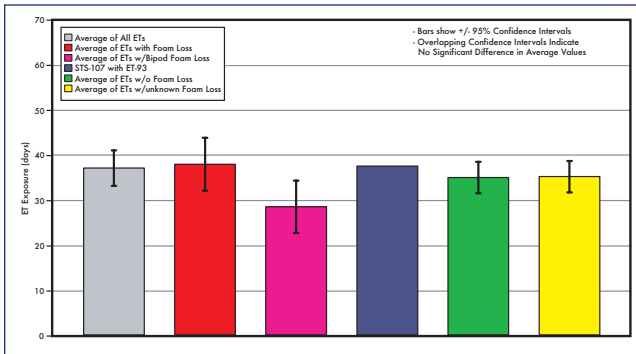
Figure 9-4. ET exposure time (to weather) for STS-107 compared to ET exposure time for missions with and without bipod foam loss.

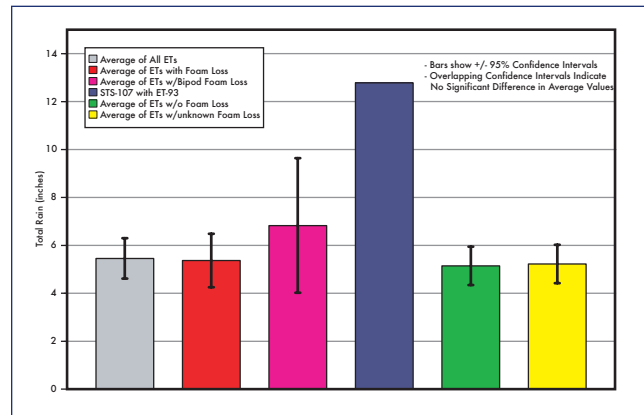
examined total rainfall, maximum one-day rainfall, average daily rainfall, launch day rainfall, and L-5 days through lift-off total rainfall. Figure 9-5 shows the total prelaunch rainfall for all STS missions. As shown in Figure 9-6, although the STS-107 value for total prelaunch rainfall, 12.78 inches, is greater than the mean value for all mission, 5.45 inches, the data are inconclusive as to whether a correlation can be

Figure 9-6. Total rainfall for STS-107 compared to total rainfall for missions with and without bipod foam loss.

made for ET bipod foam loss as a function of total rainfall prelaunch. The 95% confidence limit of the missions with ET bipod foam loss overlaps the confidence interval for all missions, as well as missions with no foam loss.

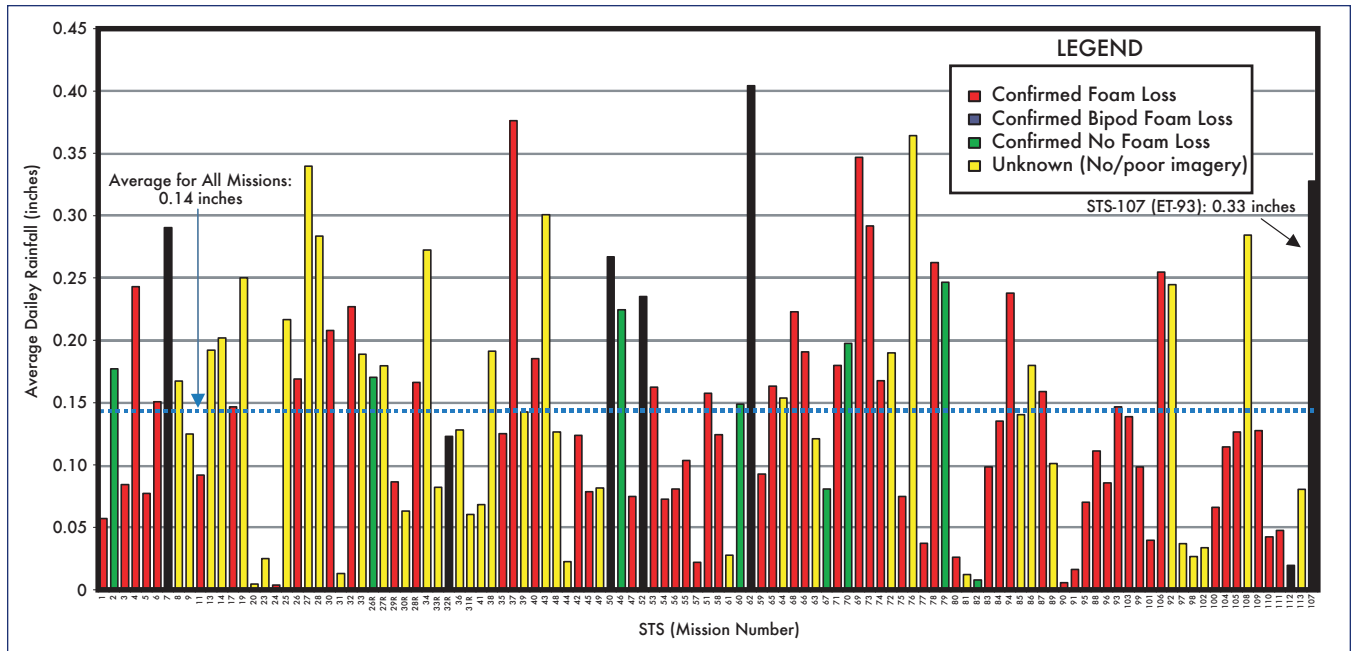
Figure 9-7. Average daily rainfall prelaunch for all STS missions (above).

Similarly, the other rainfall parameters studied (e.g., average daily, day-of-launch) reveal no correlations for ET bipod foam loss. Figure 9-7 and Figure 9-8 show the data correlation for average daily prelaunch rainfall. The STS-

107 value, 0.33 inches, and the mean value for missions with bipod foam loss are greater than the average mission value, 0.14 inches. However, the confidence intervals overlap each other, and the data are inconclusive as to whether average daily rainfall and ET bipod foam loss can be correlated.

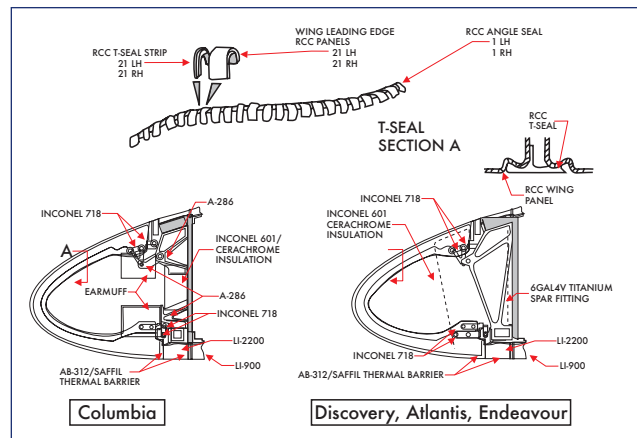
Figure 10-4. Wing leading edge RCC.

The angle seal at RCC panel 1 on the left wing leading edge (see Figure 10-4) was removed to support the evaluation of the horse collar gap filler between the adjacent tiles. During the removal attempt, the upper bushing remained bound with the shipside clevis. During subsequent attempts, the angle seal was manually manipulated to try and remove the preload. During the KSC paper review, structures engineers realized that the load applied to the angle seal was specified to be kept below 20 pounds, but was never recorded in the

paper. The RCC specification requires that RCC panel loads be kept below 30 pounds. Subsequent tests at KSC verified that the angle seal load was below the 30-pound requirement. The LESS prevention and resolution team is addressing the issue of how to measure the load and how to support the seal in future operations. Work continued on the elevon flipper doors. Flipper door 1 blade seal was not making contact with the rub channel, potentially leading to excessive venting from the elevon cove area. This issue surfaced twice during this flow and was Material Review (MR) accepted to fly as is. Modification was made to the Inconel trailing edge seal and bulb seal on the elevon. Additional work was performed on the elevon cove corrosion protection again to reduce the excessiveness of the application.

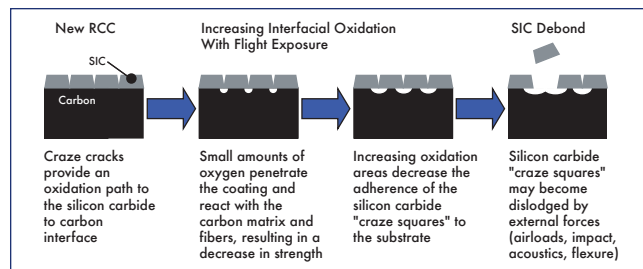
Figure 10-7. RCC corrosion process.

Subsurface oxidation has been discovered beneath the silicon carbide surface cracks in the sealant and coating which allow the oxidation process to thrive. This process is considered to be an impact to RCC mission design life, but is not generally considered to be a safety of flight issue. This oxidation process (Figure 10-7) starts with the breakdown of

the coating due to entry heating. Surface craze cracks allow oxygen to migrate to the subsurface carbon fibers and react with them. This increase in oxidation develops into larger crazed areas, which eventually allow pieces to become dislodged due to vibration, aerodynamic, or thermal loads. Once the pieces dislodge, they leave a large path for the oxidation process to continue.

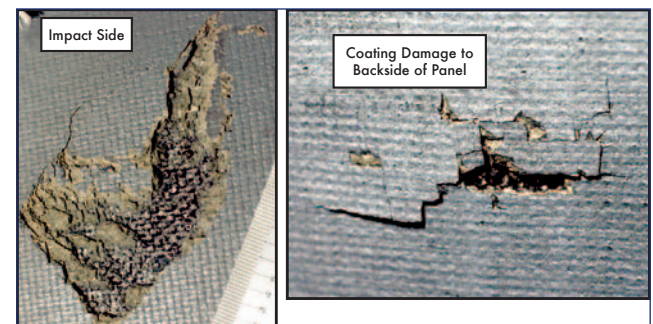
Figure 10-11. RCC impact damage.

There have been damaged RCC panels that were discovered after the vehicle returned from space on various missions. Some of the impact damage was only to the surface, but some even caused damage to the coating on the backside of the panel. In 1992, after STS-45, significant impact damage (overall length of ~1.75 inches) was noted on RCC panel

10R on *Atlantis*. The damage (Figure 10-11) was theorized to come from orbital debris or micrometeorite impacts during the mission. This type of RCC damage is of particular concern in that a significant impact could cause a hole in the RCC large enough to lead to wing spar burn through and subsequent loss of crew and vehicle. At that time, the maximum acceptable hole size (0.040") criterion was established for processing flows and advanced wing leading edge internal insulation was modified to reduce the risk should hot gas penetrate the RCC.

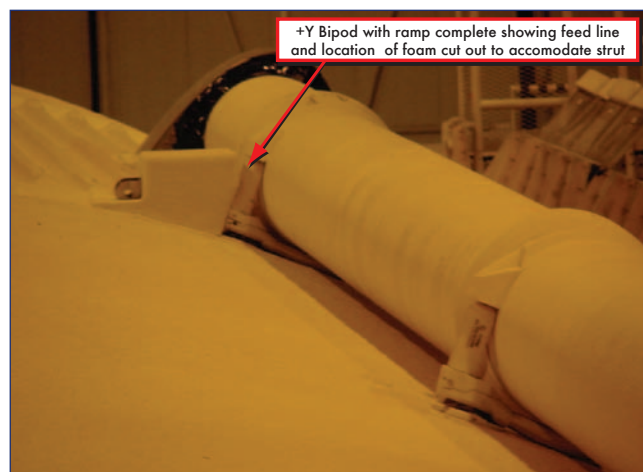
Figure 11-2. Right (+Y) bipod ramp.

TPS loss on the right bipod ramp has never been observed. Launch/ascent imagery from ground assets is less favorable for seeing right bipod foam loss as compared to the left bipod, and post-ET separation crew imagery is random between imaging the left or right bipod ramps.

There is no flight or test data to explain why the –Y (left) bipod loses foam and the +Y (right) does not. The Shuttle Program only provides the –Y ramp air loads as a worst case for ET project analysis. There are several bipod configuration differences that may contribute to foam not coming off the +Y ramp. First, the foam ramp is configured slightly differently to accommodate the inboard strut for the LO2 feed line support structure (see Figure 11-2). Second, the proximity of the right bipod to the LO2 feedline could potentially influence local surface pressure causing a lower internal to

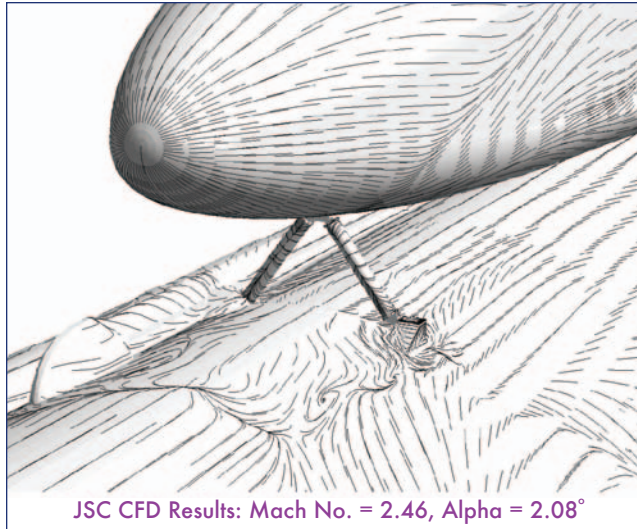
Figure 11-3. Left and right bipod ramp flow differences, CFD results.

external pressure differential (see Figure 11-3). Finally, the outboard and aft facing surface of the -Y bipod may experience lower surface pressure due to flow separation and other local effects relative to the +Y side. If the internal ramp pressure was high due to adverse “as-built” features in the ramp, this could lead to a higher differential pressure on the -Y versus the +Y ramp. However, the aerodynamic loads analysis reviewed in Section 3.5 shows that the loads on both ramps are below their design requirements.

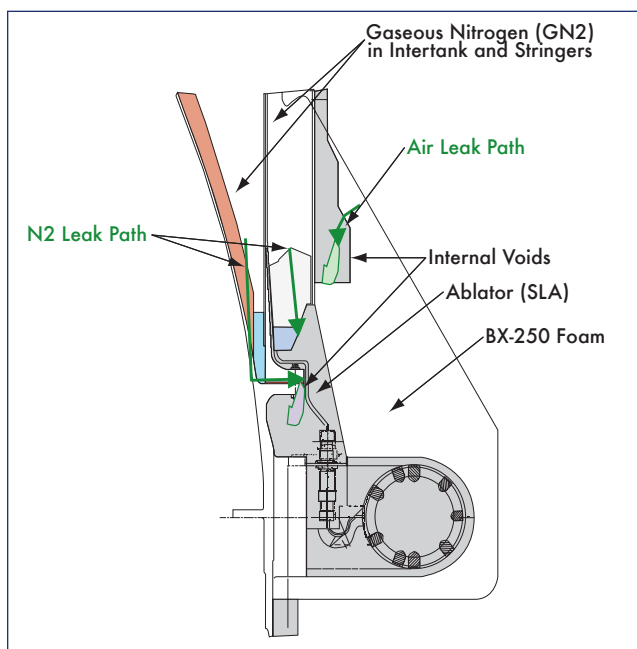
Figure 11-8. Schematic of bipod ramp - potential cryopumping.

Cryopumping could contribute to bipod foam loss, shown schematically in Figure 11-8. The mechanism that drives cryopumping is the transformation of a gas to a liquid at cryogenic temperatures. Gases may condense within a void or porous material liquefies when in contact with structure below -297°F for oxygen or -320°F for nitrogen. Pressure is reduced locally due to the condensation. If a leak path exists, more air will be “pumped,” providing more gas to condense. When the structure warms, the consequence of cryopump-

ing is that the liquefied air returns to the gaseous state with a local pressure increase. If the leak path is large, gas escapes with no detrimental effect. However, if the leak path is small, cracks may form in the TPS to relieve pressure, or a rapid increase in pressure may result in a divot. In order for this to occur, the inlet source must be blocked off to avoid venting out the inlet. It should be noted that testing has been unable to demonstrate cryopumping in this application.

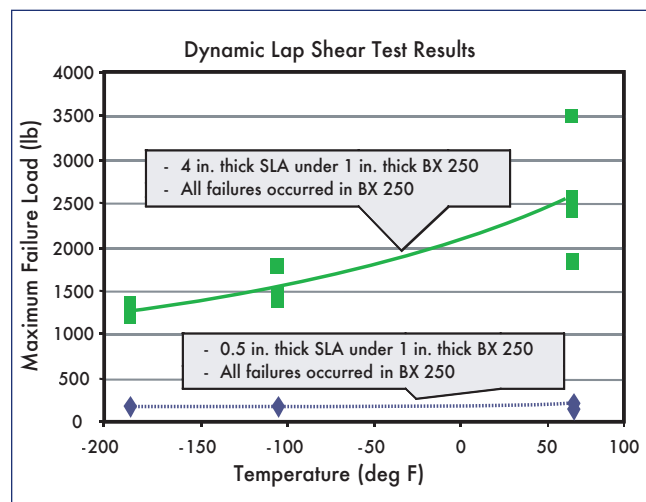
Figure 11-9. Critical test results in debris assessment.

Bipod TPS static and dynamic coupon tests were performed (test ET-TR-003). The objectives of these tests were to evaluate the BX-250/SLA hand-pack (HP) bond line laminate mechanical properties and investigate whether liberated BX-250 material could “pull” or “tear” SLA HP material from the bipod region. Analysis shows the critical bipod Spray-On Foam Insulation (SOFI) ramp failure mode due to direct air load is shear failure between SOFI ramp and bipod fitting substrate.

Testing shows that the potential loss of BX-250 does not liberate hand packed SLA due to impulse loading for cryogenic applications; the BX-250 fails before the SLA. For shear, testing shows BX-250 fails before SLA at all test temperatures. For tension, testing shows BX-250 fails before SLA when SLA temperatures are less than or equal to -100°F (see Figure 11-9).
